South East Queensland Floods 2011

Creeks, streambanks and paddocks

Newsletter #2, March 2011

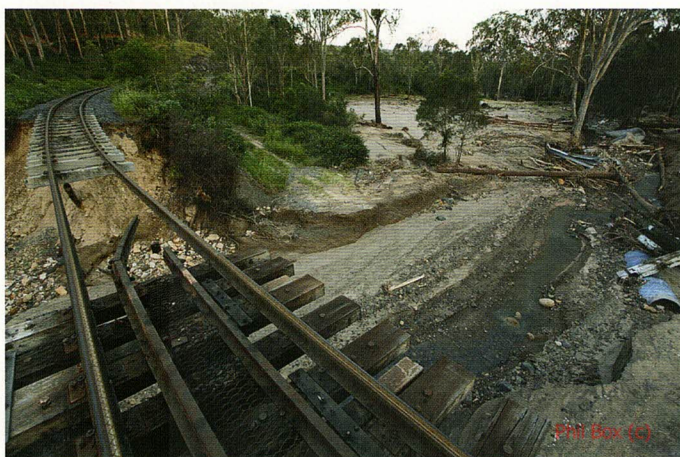
Floodwaters eroded the supports of this rail bridge in the Lockyer Valley

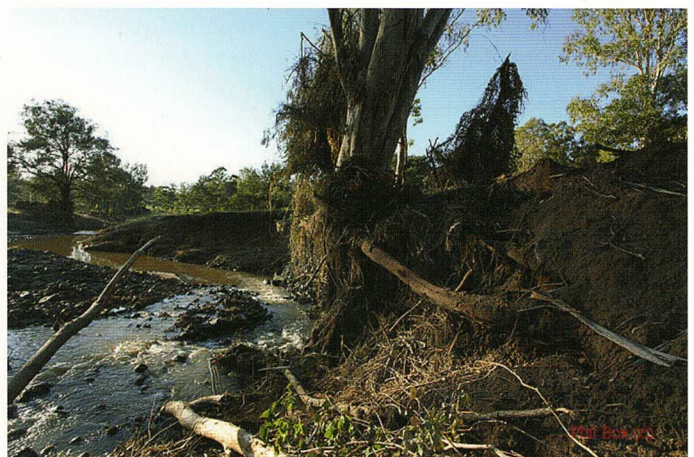
Significant streambank erosion and streambank retention aided by tree roots

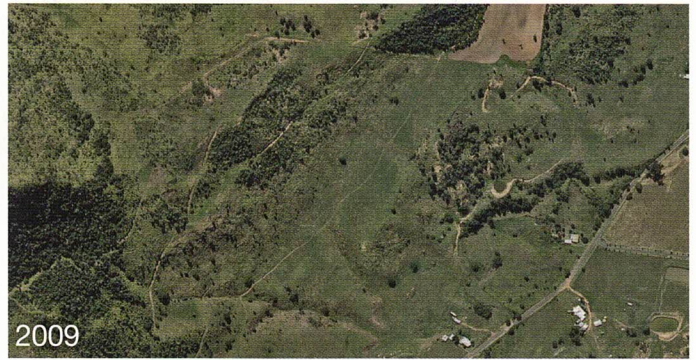
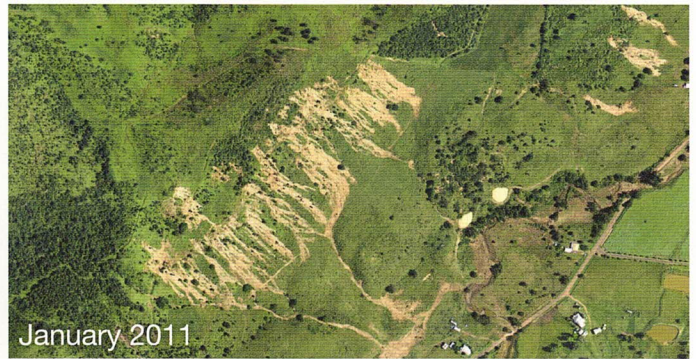
Before (top) and after (bottom) aerial photographs of landslips in the upper Lockyer catchment south-west of Blanchview.

When rainfall exceeds the catchments ability to soak it up, then surface water runoff occurs down the slope towards drainage lines and creeks on the valley floor. This runoff can cause erosion when vegetation cover is insufficient to protect the soil surface. Removal of the woody vegetation cover can also lead to mass failure of the hillslopes. When trees are removed, particularly in steep terrain, the lack of root reinforcement can lead to landslips when the soils become saturated. Gully erosion can also occur due to increased surface runoff when water enters the soil profile and erodes through the soil layers to form gully structures. Lack of vegetation and ground cover increases erosion.

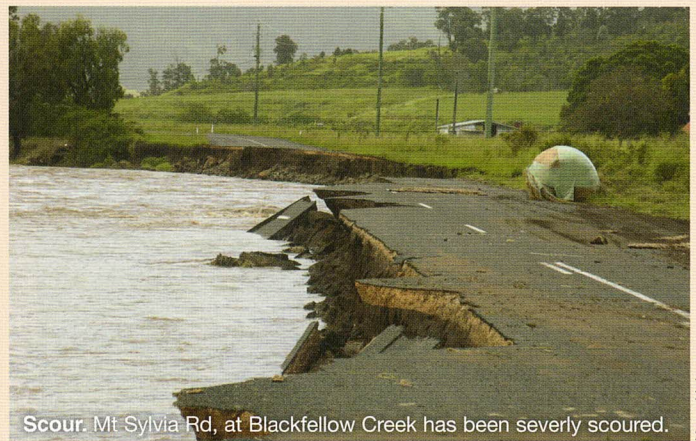
Scour. Mt Sylvia Rd, at Blackfellow Creek has been severely scoured.

Streambank scour is the direct removal of streambank materials by the physical action of flowing water. These erosion processes occurred mainly in the upper tributaries and smaller streams, due to high flood flow velocities. As the flow increases, the erosion power of the water also increases. Extensive areas of scouring to bedrock has occurred in Murphy's Creek, Lockyer Creek and the Brisbane River. The power of the water was so great that massive boulders and large trees have been dislodged, uprooted and carried a considerable distance. When water velocities reduce, sediment and debris are deposited downstream in the river. During the recent flooding this resulted in deposition of large amounts of mud, sand, gravel and boulders where the flow of water slowed due to a reduction in the slope of the channel and widening of the creek in downstream reaches.

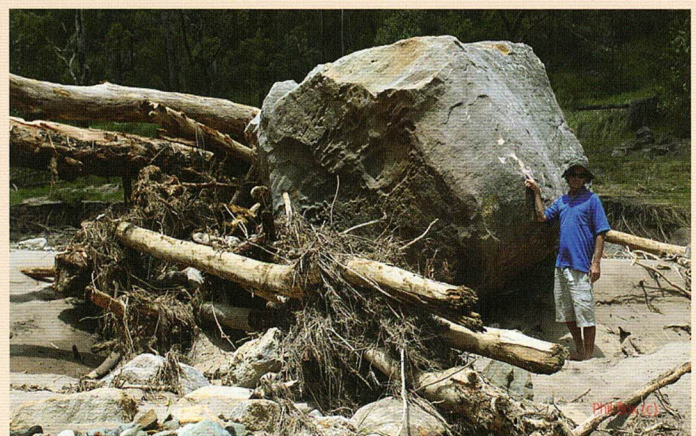
Deposition. This boulder at the junction of Fifteen Mile Creek and Paradise Creek (see map, back page) was moved about 100m by the force of the floodwaters.

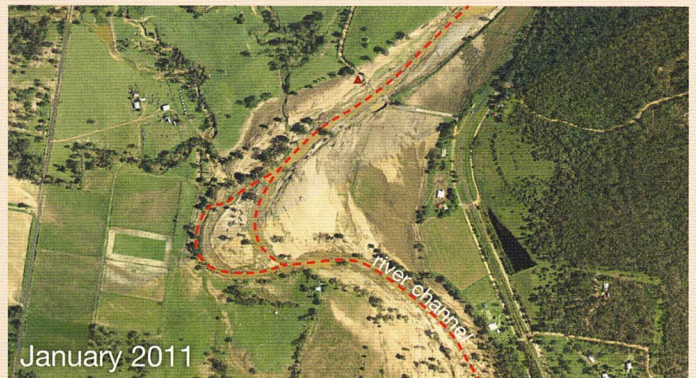
Before (top) and after (bottom) aerial photographs of river widening downstream of Willows Bridge, Lockyer Siding.

As streams flow through valleys they create meanders (large loops). When flood events occur, the water cuts and erodes the outside of the curve (A) and deposits sediment on the inside of the curve (B). This occurs because the water moves more rapidly on the outside of the curve and more slowly on the inside. When the volume of the water increases rapidly and flow is swift, meanders can be cut off and new channels formed. During floods and flash flooding, as occurred in the Lockyer catchment, channels can be widened, deepened and realigned.

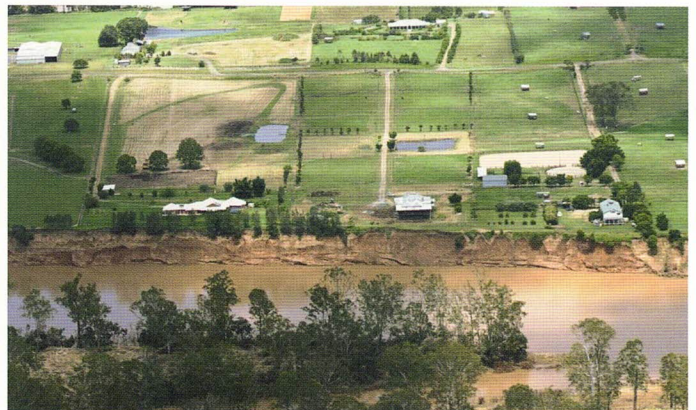
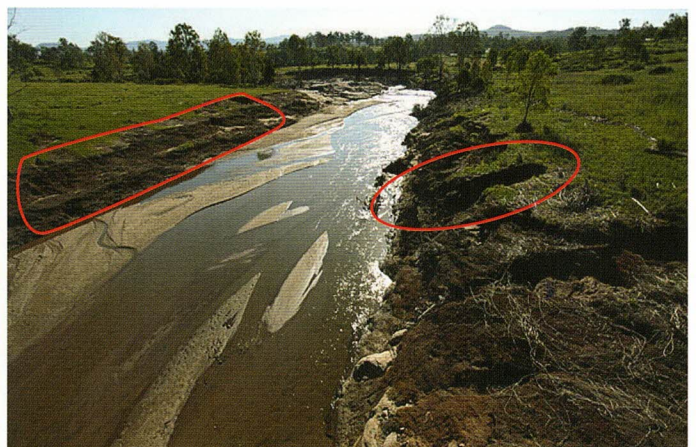
Streambank erosion in the Brisbane River upstream of Moggill (top) and streambank collapse in Lockyer Creek at Lockyer Siding (bottom).

Streambank collapse has occurred along many kilometres of the waterways, as evidenced by bare and near-vertical streambanks, and areas of slumping. The collapse and slumping is a direct result of the physical action of flood waters scouring out the base of the streambanks, with large sections becoming unstable and toppling into the stream.

Inundated streambank soils are also subject to slumping following the rapid drop in water levels after the flood has passed.

The lack of streambank vegetation in some areas also contributed to slumping. On stable banks as deep rooted trees lower the water content of soil and increase the soil cohesiveness through the root network.
